Corrigenda

Installation Guide contain incorrect descriptions. Refer to the following table and confirm the descriptions that are corrected.

WV-X1571LN / WV-X1551LN / WV-X2571LN / WV-X2551LN / WV-S1572L / WV-S1552L / WV-S2572L / WV-S2552L / WV-X4573L / WV-S4551L / WV-X4573LM / WV-S4551LM

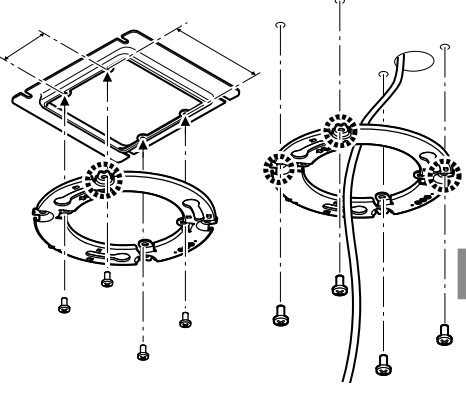
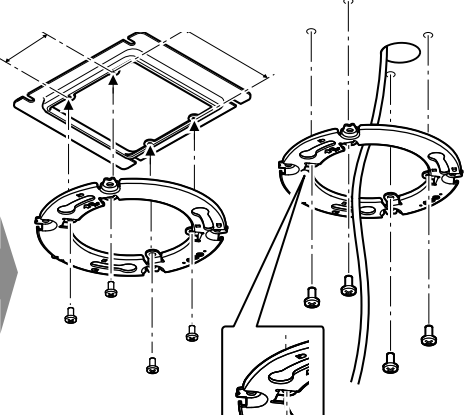
Processing the installation surface (process according to the installation type)

| Incorrect | Correct |

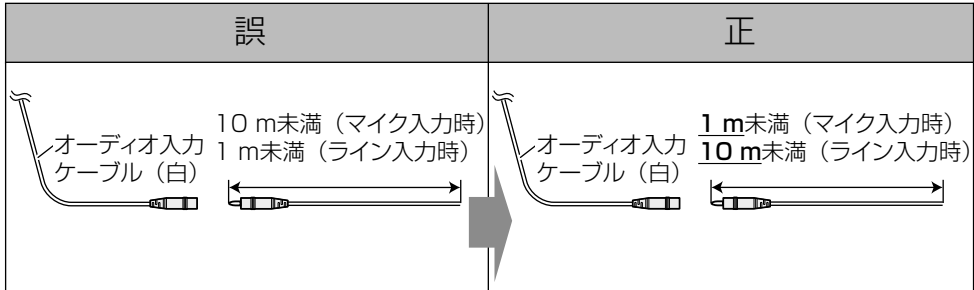
接続する

取扱説明書 設置編に記載の誤りがありました。以下に正しい内容を記載します。
